Report on Water Quality
in
Loughborough Lake
1972

LOUGHBOROUGH LAKE

1972

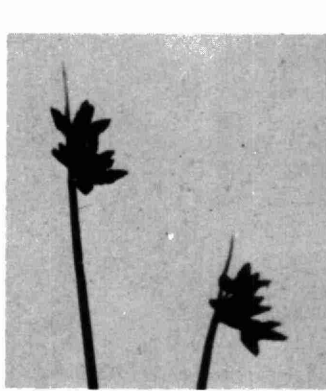
FIGURE 10: Photographs of some common aquatic plants found in Loughborough Lake.

Figures 10 and 11 are photographs of some of the more common weeds found in Loughborough Lake.

Aquatic weeds representing fourteen genera, from which ten different species were identified, were found in shoreline areas of Loughborough Lake (Table 1). Some of the plants could only be identified to genus because of the lack of fruiting and flowering structures (e.g. milfoil, buttercup, bulrush). Figure 9 outlines the location and extent of the weed beds and lists the weeds found in each area. While this figure shows the distribution of the weeds, the density or dominance of any particular plant type was not determined.
